MAPLEWOOD POLICE AND COURT BUILDING: A POST OCCUPANCY EVALUATION

December 2010

Prepared by Rutgers Center for Green Building & Associates:

Prepared for:
U.S. Green Building Council – NJ Chapter

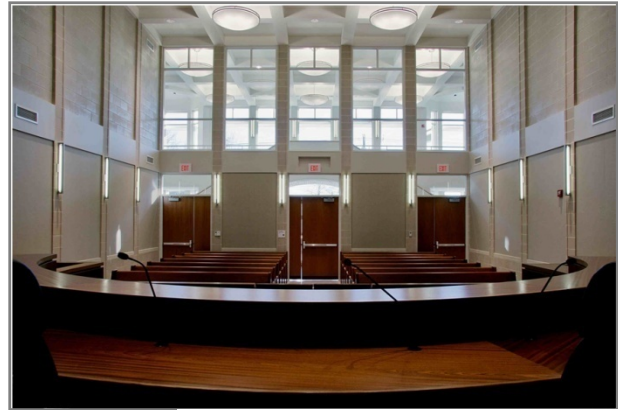
Image 4: Interior of courthouse.
Source : Image Up Studio, Metuchen, NJ

The first floor has two conference rooms that are available for public meetings, a courtroom and court facilities, and 9-bay garage and controlled entry to the secure section of the building which contains the command center and several meeting rooms and offices.

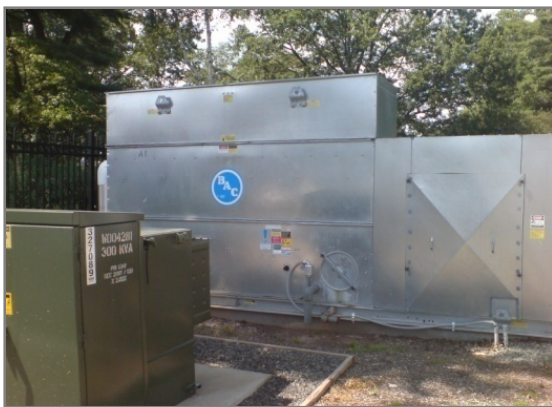
Image 5: Ground-mounted cooling tower.
Source: ClintonAndrews

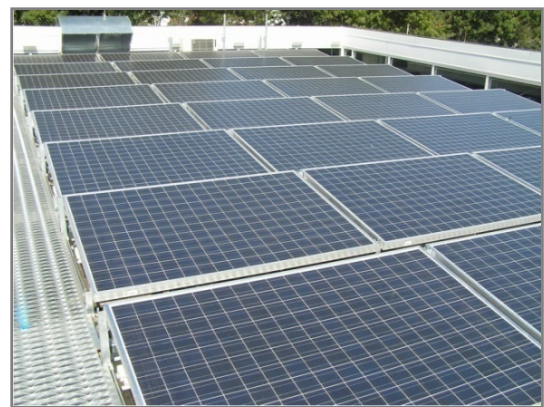
Image 6: Rooftop PV array.
Source: Image Up Studio, Metuchen, NJ

The solar photovoltaic (PV) array is another major green feature; however, because it is located on the roof it is not visible to casual observers. To help make the use of this technology visible to the public, there is a live display in the front lobby of the building that reports in real time how much electricity the PV system is generating.

The solar PV system appears to be working well and in line with pre-construction modeling. The system as designed is the maximum size that can fit on the roof and generates substantial amounts of electricity throughout the year, reducing utility electricity purchases by about 2-7 % annually.

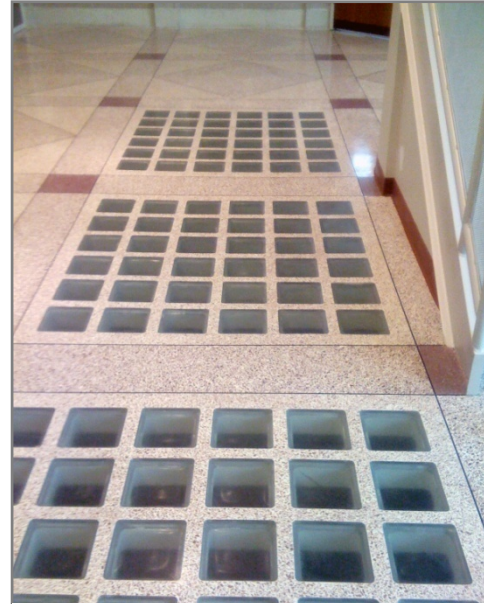
Image 8: Glass tiles in foyer floor allow daylight to penetrate into basement. Source: Clinton Andrews

Daylighting design perhaps is the most noticeable green feature. The foyer includes an atrium brightly lit by first-and second-floor windows. The floor of the foyer includes a section made of glass block to allow daylight into the basement exercise room below. Transparent upper walls at one end of the courtroom allow daylight from the atrium to penetrate deep into the sizable interior space. Exterior offices and conference rooms enjoy large windows equipped with adjustable shades, and feature upper windows that use more highly transparent glass than the eye-level windows to reduce glare and allow deeper penetration of daylight. A single row of windows surrounds the entire second floor, allowing an abundance of natural light into the offices, conference rooms, and main lobby. These windows feature exterior light shelves to reduce glare. The third floor has clerestory windows for natural light. Stairwells also have windows, providing light and visibility for safety. Electrical lights are equipped with daylight sensors.

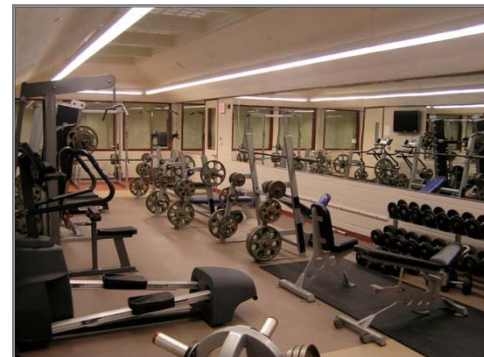
Image 9: Basement exercise room with daylight provided by glass tiles in floor above. Source: Image Up Studio, Metuchen, NJ

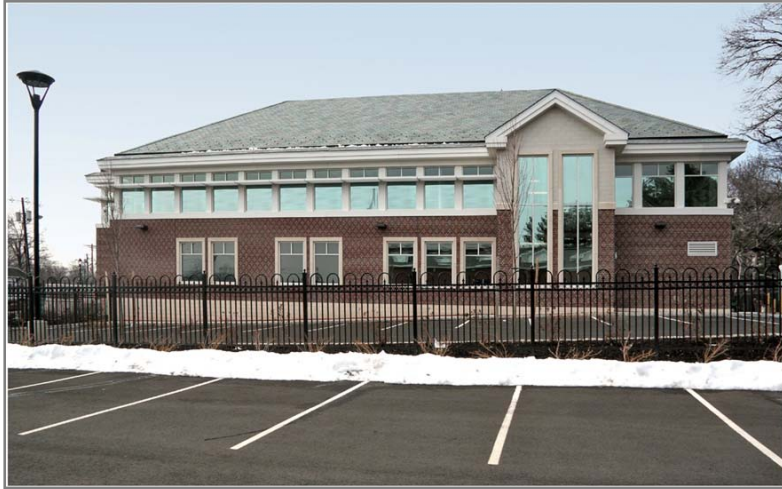
Image 10: Building exterior showing clerestory windows. Source: Image Up Studio, Metuchen, NJ

similarity to other Maplewood municipal buildings. Clerestory windows (faced with a *brise-soleil*) form a ribbon around the building just under the cornice. The roof consists of a series of hipped sections with two small polygonal dormers near the front. The design intended for the building to be consistent with the 1920s historical revival style of other township buildings.

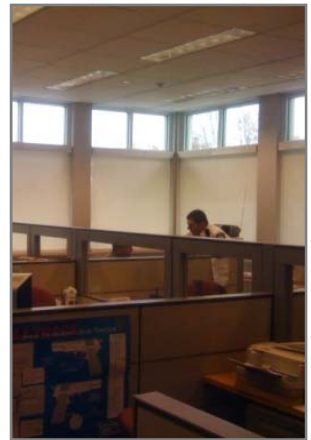
Image 11: Offices with shades drawn. Source: Clinton Andrews

The daylighting strategies largely seem to work well. Daylight reaches into the courtroom during the daytime and most exterior offices and conference rooms have their lights turned off. However, window blinds are closed in some offices with computer screens because of glare.

Occupants have a mixed perspective on the daylighting. On the one hand, as noted above, people like the availability of daylight, and we noticed that during daytime hours exterior room electric lights were left off, suggesting that the daylight provided sufficient illumination for work. Aesthetically speaking, it is a highly valued feature that seems to affect occupant mood positively. On the other hand, the satisfaction scores for work area daylighting are not uniformly high. This could be for several reasons. First, in spite of the use of light shelves and shades, glare has been a problem in some areas. Workers in a detective’s room on the east side of the building, for instance, had so much difficulty viewing computer screens that a solar film to was added to the highest area of the clerestory windows to reduce glare. During one morning interview in the first floor east conference room, a laptop screen was very difficult to read even with the blinds drawn.

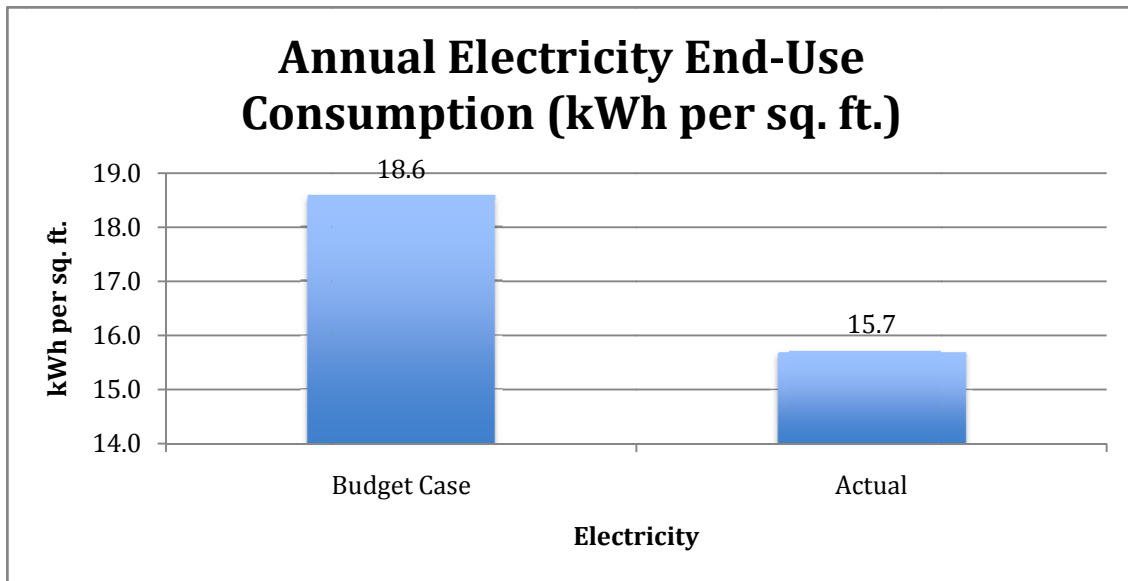
Figure 16: Annual End-Use Electricity Consumption (kWh per square foot)

Figure 16 shows that the electricity usage of the as-built building is 15% lower than that estimated for the conventional, budget alternative. Figure 17 shows that natural gas usage goes the other direction, with the as-built building consuming 37% more natural gas than its conventional alternative. However, as noted in an earlier section of this report, the natural gas modeling numbers are suspect, and, in any case, the electricity costs are far larger than the natural gas costs on an annual basis.
