Cost-Effective Detection of Multi-Family Housing-Related Health and Safety Standards

January 27, 2017

Submitted in partial fulfillment of grant obligations
Healthy Housing Technical Studies Grant # NJHHU0019-13

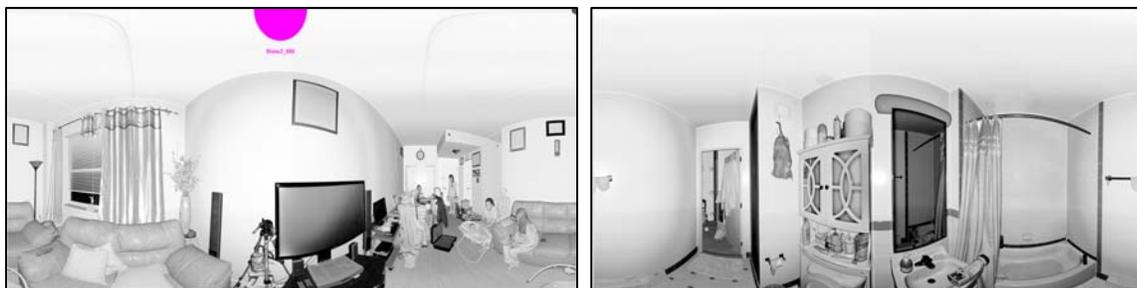
Figure 3. 3D view of scanned living room and bathroom

Terrestrial Laser Scanning: Terrestrial laser scanners are used to collect point cloud data of building structures. To provide sufficient 3d information of the building, one or more scans were collected per room (Figure 3).

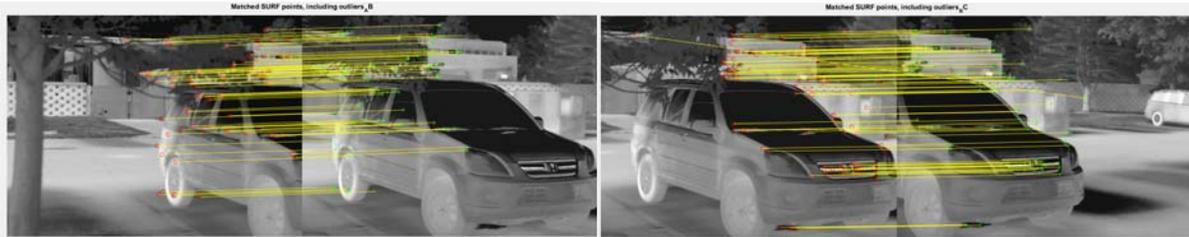
Figure 7. Matched SURF points, including outliers.

To address this issue, our approach tries different temperature scales and finds the best result in terms of a number of feature points, matched points, and inliers. Once the transformation between images with highest inliers was calculated, these images can be combined to form a panoramic image that can be transferred to any color scale and color palette with a fixed transformation (Figures 6 and 7).

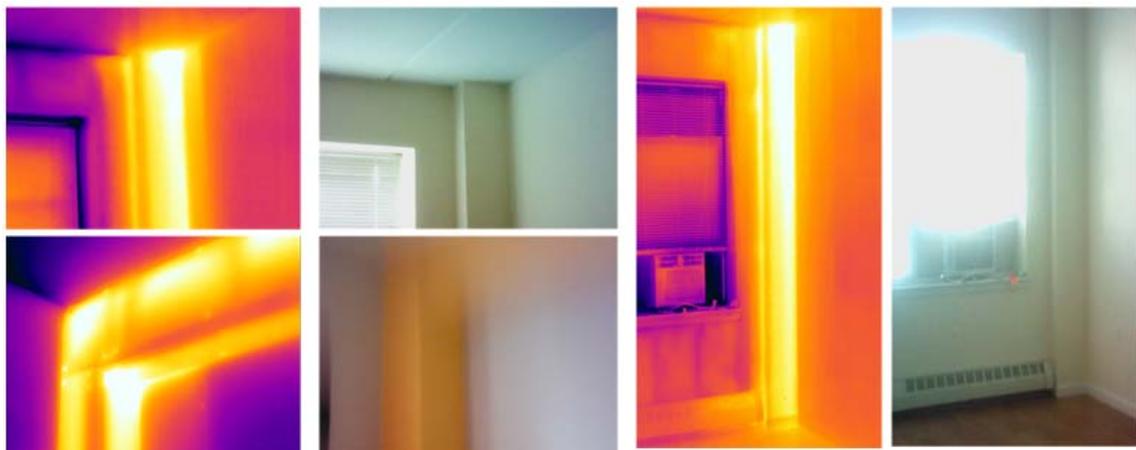
Poorly insulated hot water riser: During field data collection for Building 2, we noticed that some of the hot water riser pipes were not well insulated (Figure 25). The highest temperature difference between the wall cover of the riser and surrounding wall in the same room can reach up to 13.2 °F. In this particular building, three out of fifteen apartments had a temperature difference of 10°F, seven of fifteen apartments had the temperature difference higher than 5°F, and 66% of apartments had the temperature difference higher than 4°F. Insulating the pipes that carry hot water can help reduce the convective heat loss from pipes and increase the delivered water temperature for end use apartments. On the other hand, if the heat gain from poorly insulated hot water pipes cannot be controlled, it may lead to an overheating issue in the room.

Figure 25. Poorly Insulated Hot Water Risers.
