Cost-Effective Methods for Detection & Improvement of Indoor Air Quality

Dr. Jennifer Senick, Executive Director

Rutgers Center for Green Building, Edward J. Bloustein School of Planning and Public Policy, Rutgers, the State University of New Jersey

September 16, 2019

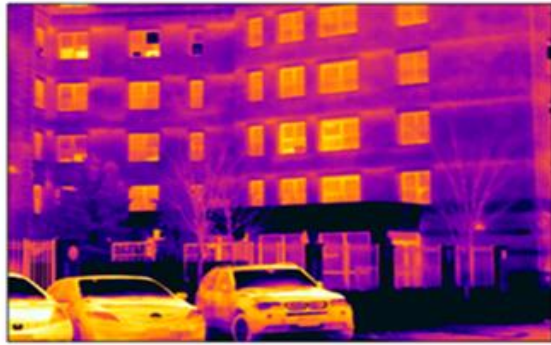
Infrared Technology for Building Diagnosis

Benefits of thermal Infrared–based building diagnostic:

- Rapid data collection
- Provide visual and recordable information
- Nondestructive testing
- Safe working distance
- Price affordable

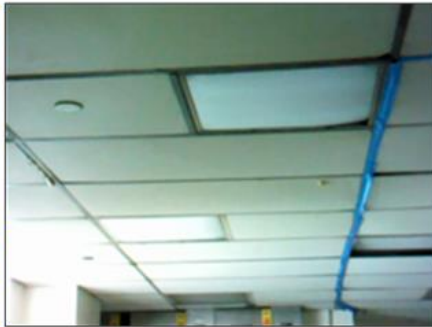
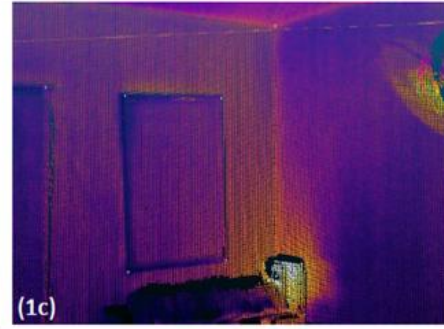
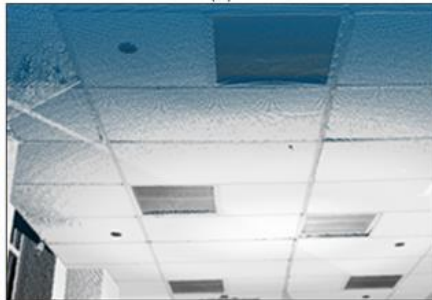
Projecting Infrared Image Onto Scan Data

Indoor 3D Thermal model: provide us with dimension and area information

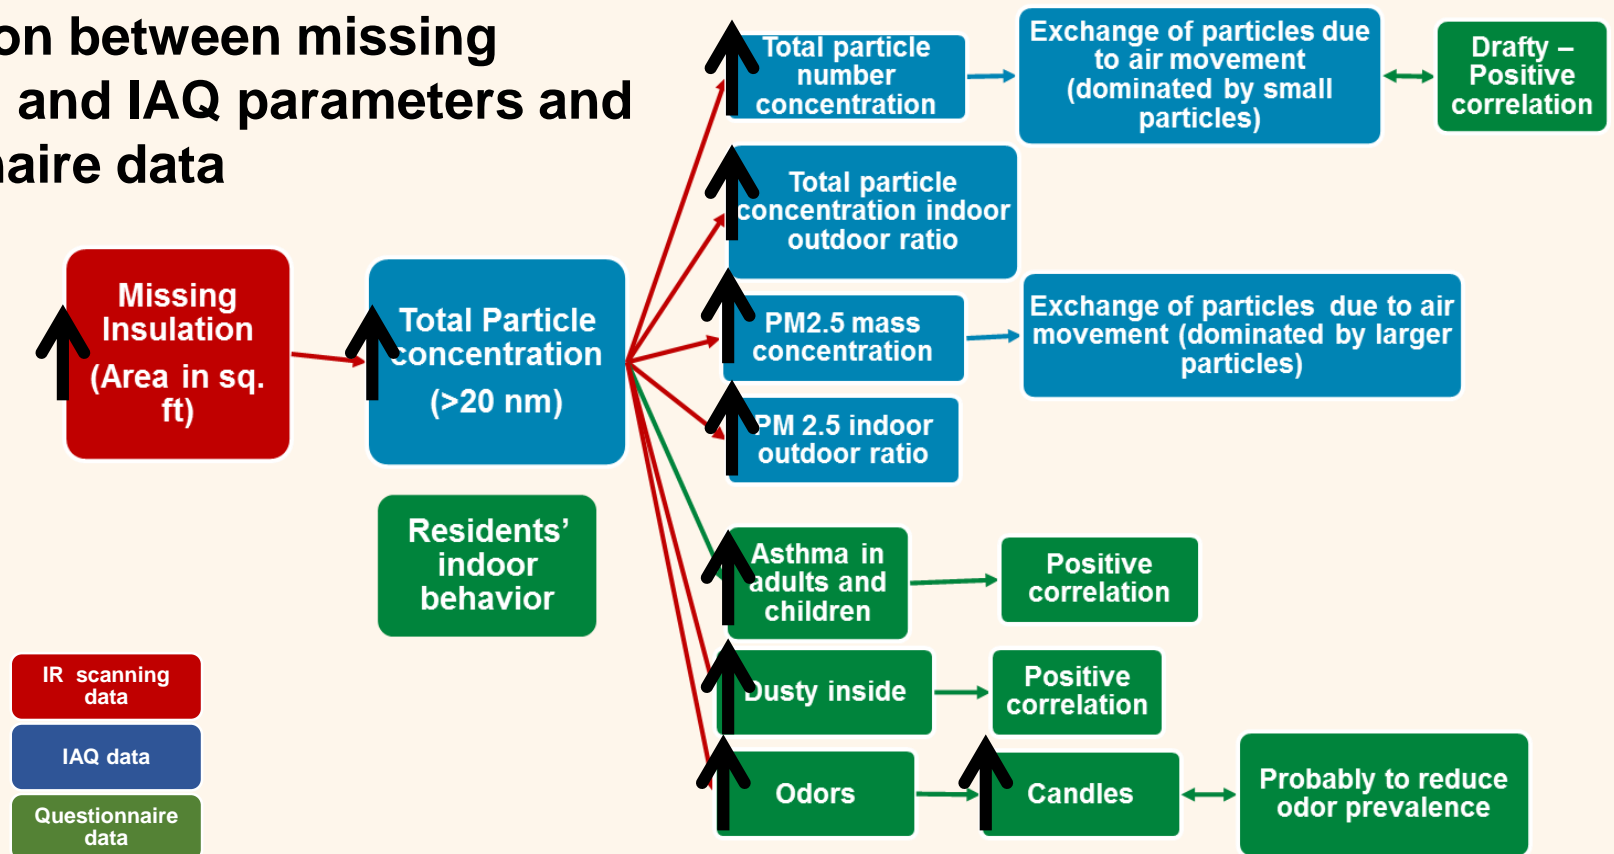
Association between missing insulation and IAQ parameters and questionnaire data

- IR scanning data
- IAQ data
- Questionnaire data

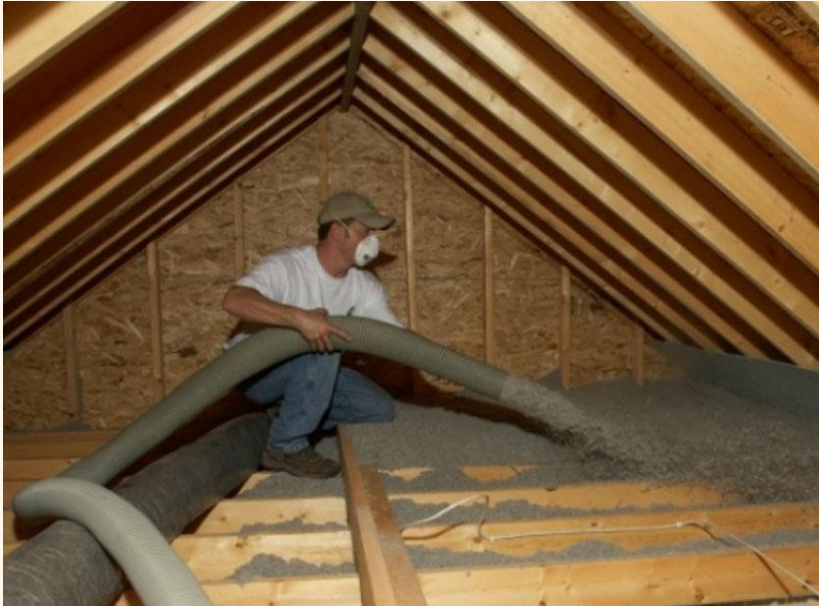
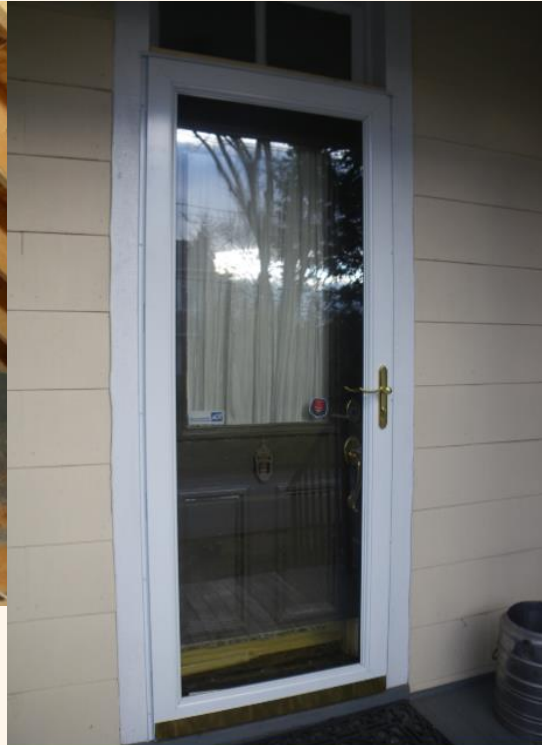
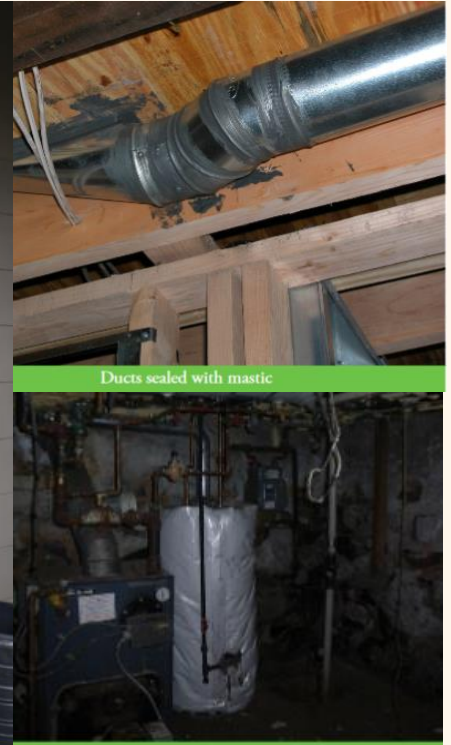
Cost-Effective Envelope Improvements

Storm door installed to provide added protection

Added insulation in basement (before barrier)*
