# Aquatic Connectivity Through Climate-Ready Infrastructure

Partnership with the  
Rutgers Raritan River  
Consortium

# Coastal Watershed Grant

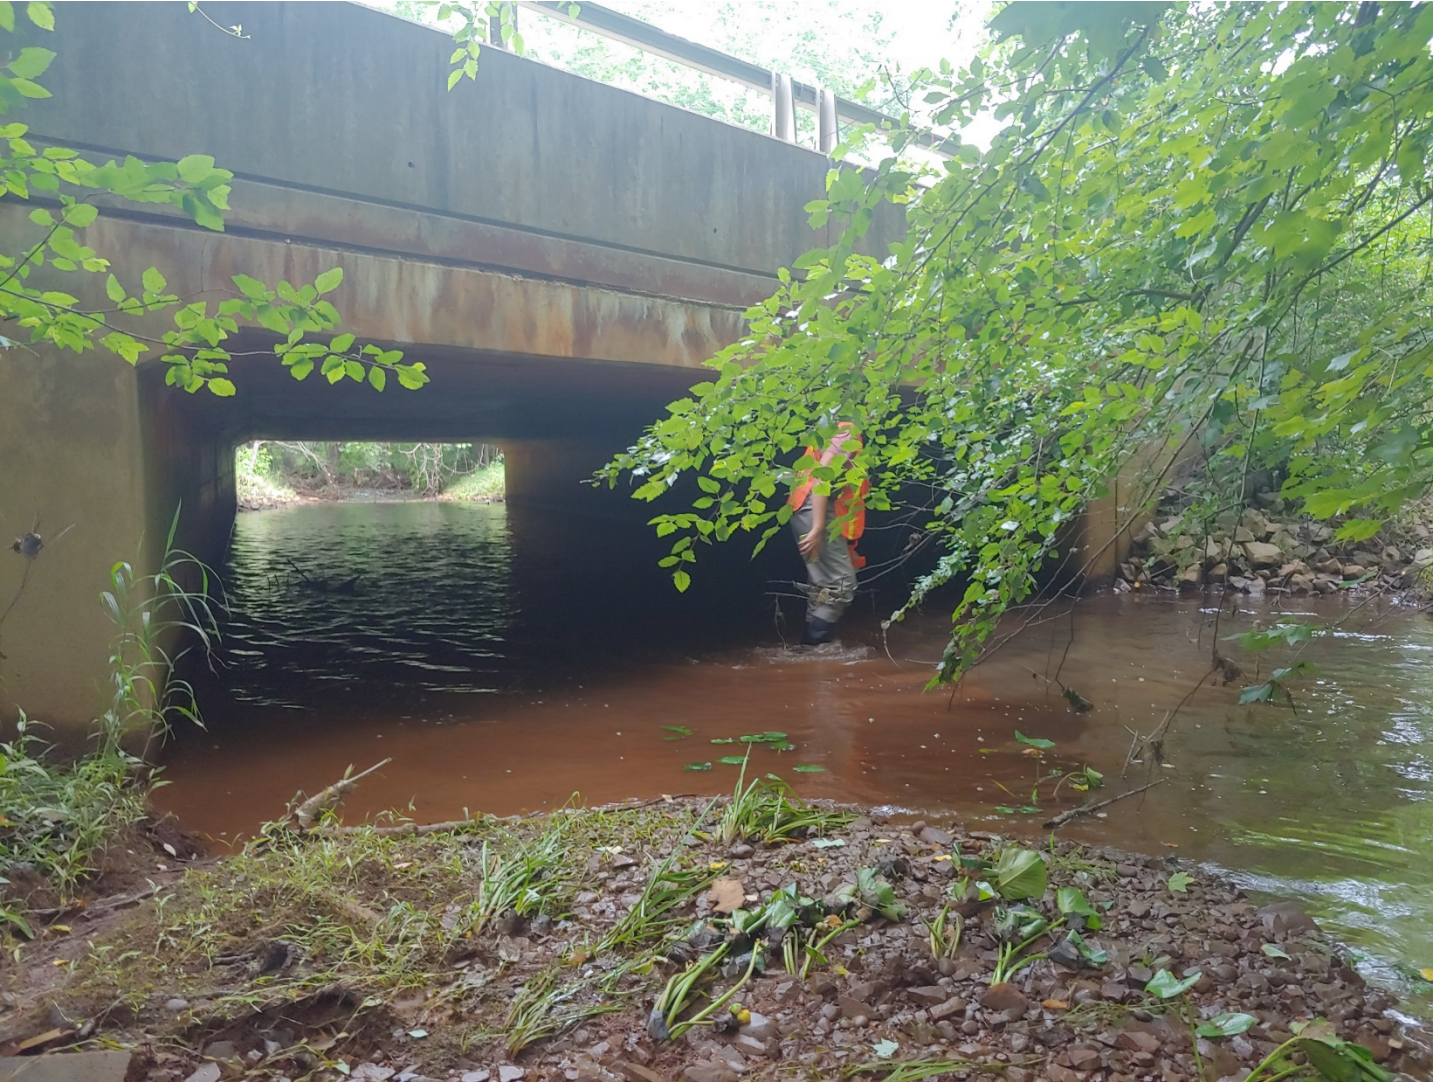
Some crossings  
were easily  
accessible and safe  
to measure so we  
could fill out the  
entirety of the  
datasheet with  
relative ease.

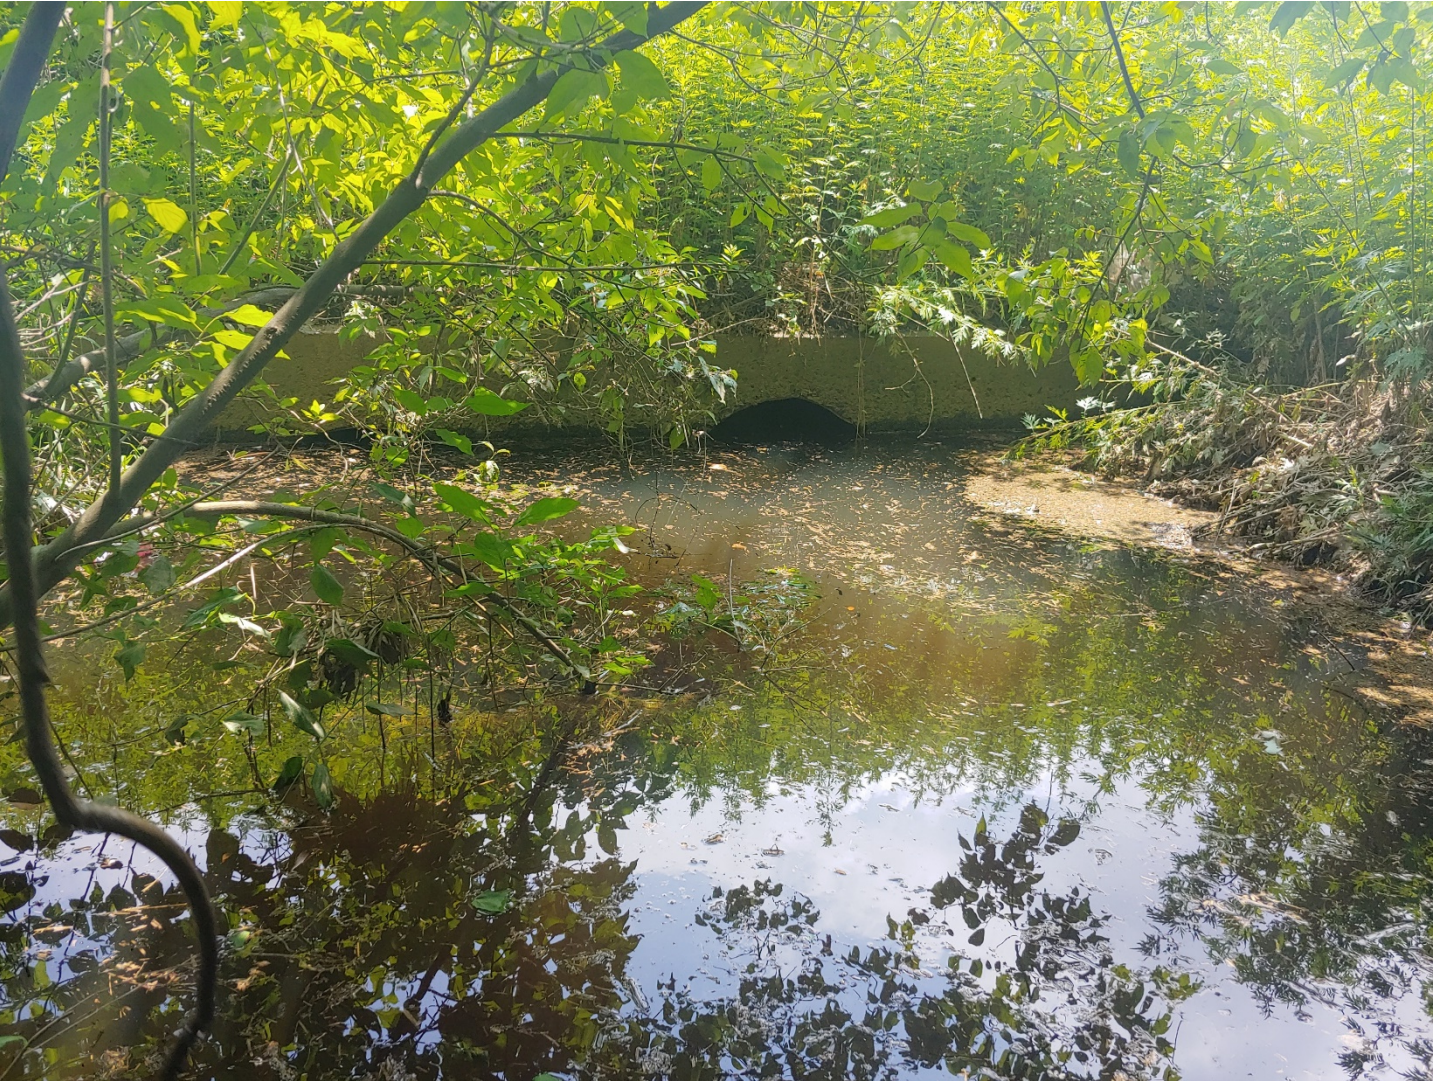
And some were not! This was a partially inaccessible culvert – we could locate it and record only some required data. This water was well above waist level and thick mud was at the bottom making it unsafe.
